PUBLICATION INDEX FOR SGS 1-35

K & L SOARING, LLC
5996 STATE ROUTE 224
CAYUTA, NY 14824

BULLETIN NO. SA-001.6*

SUBJECT: ONE-TIME INSPECTION OF TOW RELEASE ASSEMBLY; DAILY INSPECTION OF TOW RELEASE ASSEMBLY; PILOT'S PREFLIGHT INSPECTION OF TOW RELEASE ASSEMBLY; 100 HOUR/ANNUAL INSPECTION OF TOW RELEASE ASSEMBLY.

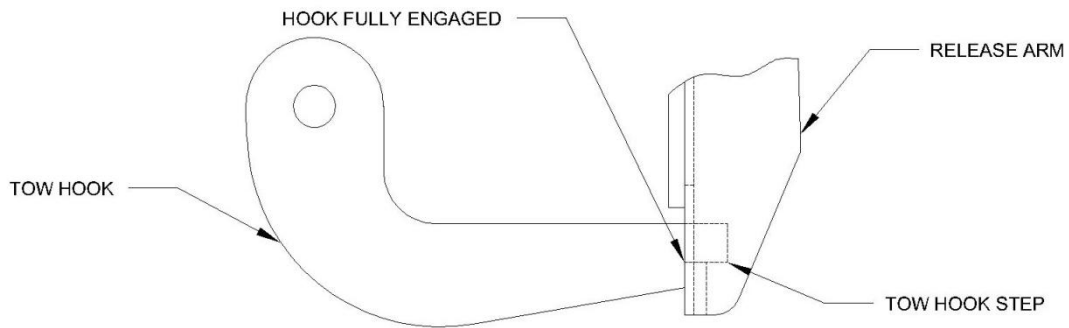
VIEW A – PROPER ENGAGEMENT

- Proper engagement of the tow hook into the release arm is shown in Figure 1, View A, and Figure 4. Excessive wear of the tow hook step could result in improper engagement. Figure 2 of this bulletin provides inspection data and wear limits for the tow hook. Tow hooks which do not meet the specified limits must either be reworked to obtain dimensions (as specified in Figure 2) or replaced.
 - If tow hooks is able to slide into the release arm, beyond the tow hook step, as shown by Figure 1, View C, the release arm must either be reworked with a slug as specified in Figure 3, or replaced.
- c. Inspect tow hook for wear in accordance with Figure 2 of this bulletin.

- Figure 1 shows the proper attachment of the tow hook into the release arm. Note that the step of the tow hook should seat against the release arm. The tow hook step must fully engage the release arm to allow the release assembly to function properly. The tow hook must not be allowed to extend through the release arm beyond the step on the hook as shown in Figure 1, View C.

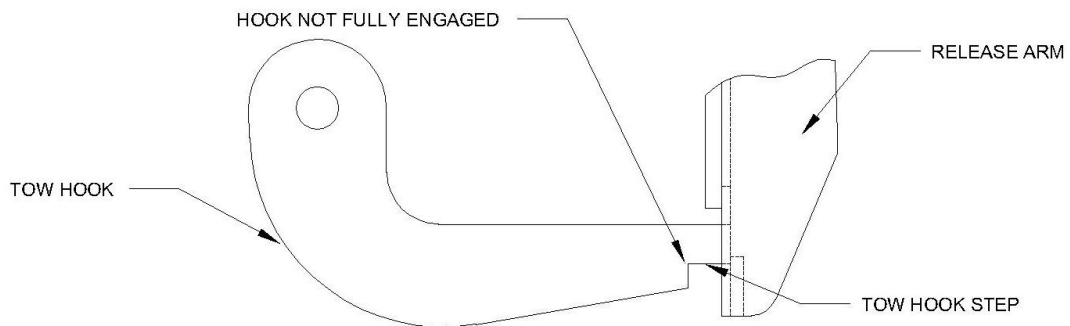
VIEW B – IMPROPER ENGAGEMENT

IF TOW HOOK IS ABLE TO SLIDE THROUGH RELEASE ARM, BEYOND THE TOW HOOK STEP, THE RELEASE ARM MUST EITHER BE REWORKED IN ACCORDANCE WITH FIGURE 3, OR REPLACED

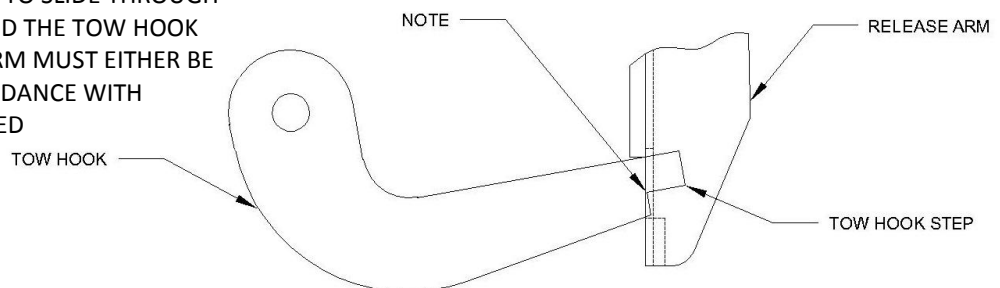
VIEW C – IMPROPER ENGAGEMENT

- g. If tow hook is able to travel too far inboard as shown in Figure 1, View C, disengage tow hook from release arm and measure the length of the release arm slot
- h. If dimension is less than 0.66 inch, rework release arm by welding on 1B-217-19 slug at location shown in Figure 3. (Release arm may be replaced as an alternate to welding on slug)
- i. If length of release arm slot is greater than 0.66 inch, replace release arm.
- j. Perform a thorough inspection of the tow hook installation in accordance with the 100 hour inspection requirements listed in Table 2 of this bulletin.
- k. Repair or replace unserviceable component(s), as required
- l. Record compliance with Part I of this Service Bulletin in Aircraft Log Book.

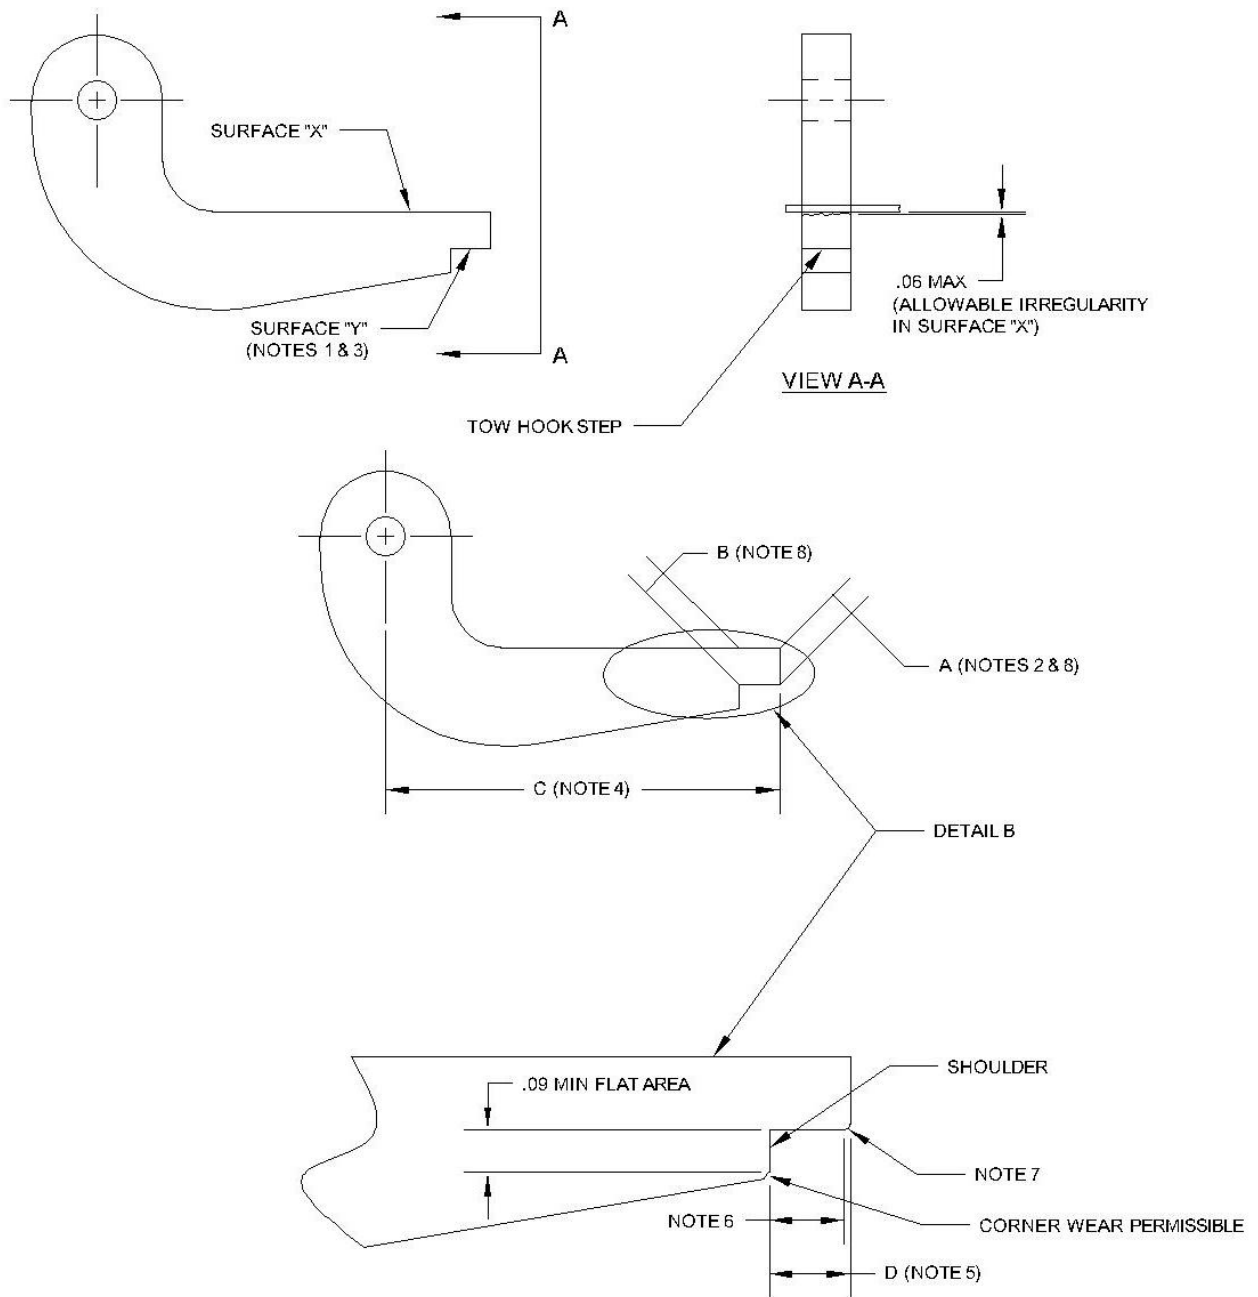
FIGURE 2 – TOW HOOK INSPECTION AND REWORK (SHEET 1 OF 2)

1. IF WEAR OCCURS ON SURFACE "Y" IT MUST BE POLISHED FLAT WITHIN TOLERANCES PROVIDED IN FIGURE 2 (SHEET 1). IF THE HOOK CANNOT MEET THESE REQUIRED DIMENSIONS IT MUST BE REPLACED. UNDER NO CONDITIONS SHOULD SURFACE "X" BE POLISHED OR MACHINED TO CHANGE ITS ANGLE.

2. DIMENSION "A" ON STD 10232-001 HOOK SHALL BE .21 INCHES MIN. & .28 INCHES MAX. DIMENSION "A" ON STD 1A218-1A, STD 1B221-3, & R-200-9A HOOKS SHALL BE .25 INCHES MIN. & .31 INCHES MAX.

6. HOOK MUST REMAIN FLAT IN THIS AREA FOR A MIN. OF .21 INCHES FROM SHOULDER OF HOOK.
7. WEAR OUTSIDE OF THE .21 MIN. FLAT AREA IS PERMISSABLE.
8. DIMENSION "B" MUST BE EQUAL TO DIMENSION "A", OR LESS THAN DIMENSION "A" BY NO MORE THAN .015 INCHES AND CANNOT BE GREATER THAN DIMENSION "A".

- d. If tow hook dimensions are not within limits specified in Figure 2, either rework the tow hook to obtain dimensions (as specified in Figure 2) or replace it with a new or serviceable, used tow hook
- e. Engage tow hook into release arm. Ensure that the tow hook properly engages as shown in Figure 1, View A.
- f. If tow hook is unable to completely engage (shown by Figure 1, View B) shorten the rubber bumper stop between the release knob and the instrument panel to allow the release assembly to close further.

9. ALL SURFACES EXCEPT SURFACE "X" MAY BE FILLED TO OBTAIN REQUIRED DIMENSIONS.

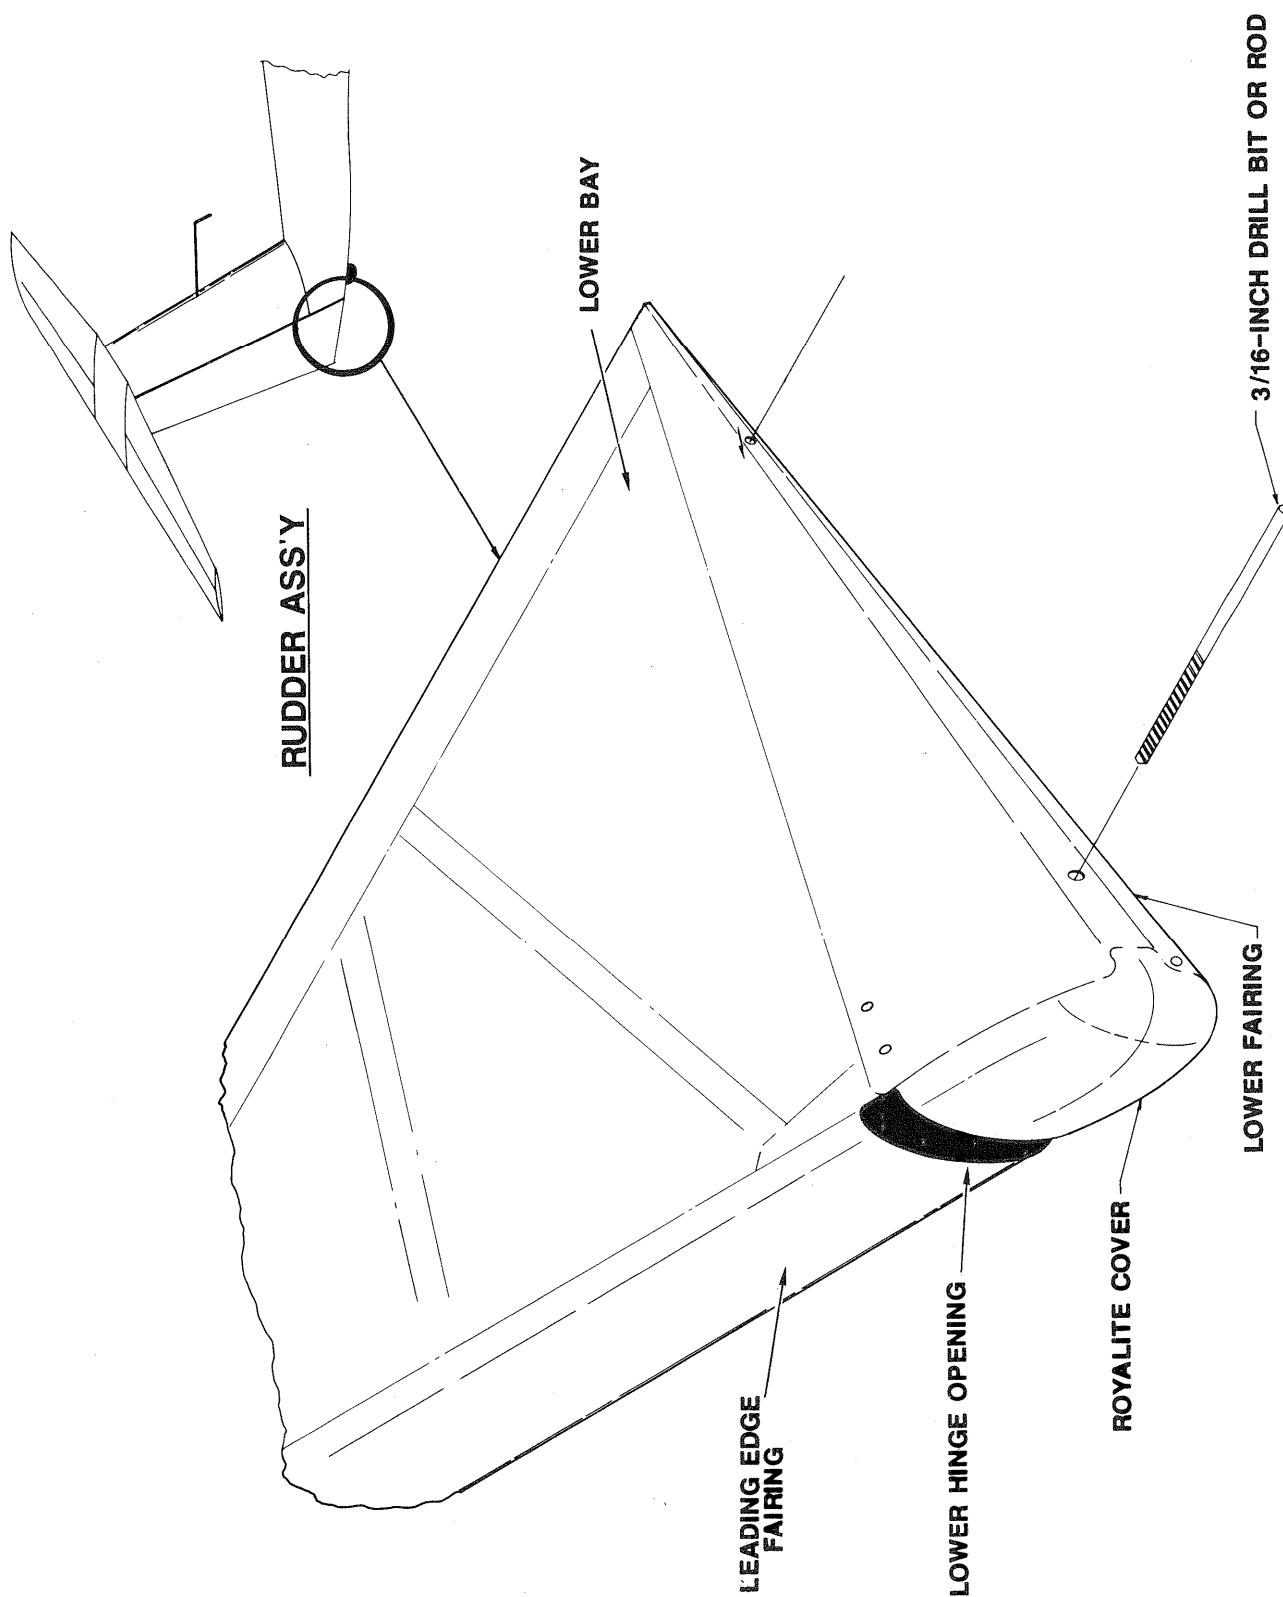
FIGURE 1

- (1) Carefully adjust rudder position to extreme left or right.
 - (2) Using a flashlight, inspect for debris inside lower fairing (Figure 1) by looking through lower hinge opening.
 - (3) If debris is found, use a vacuum cleaner with flexible extension hose to remove debris.
 - (4) Check two drain holes (Figure 1) at bottom of fairing for obstruction. Clear obstructions with 3/16-inch drill bit.
- d. Open access door on horizontal stabilizer stub (Figure 2) and use a flashlight to inspect upper fin and stabilizer stub area for debris. Use vacuum cleaner to remove debris.
- e. Inspect brake/wheel area for obstructions. Remove obstructions as required.

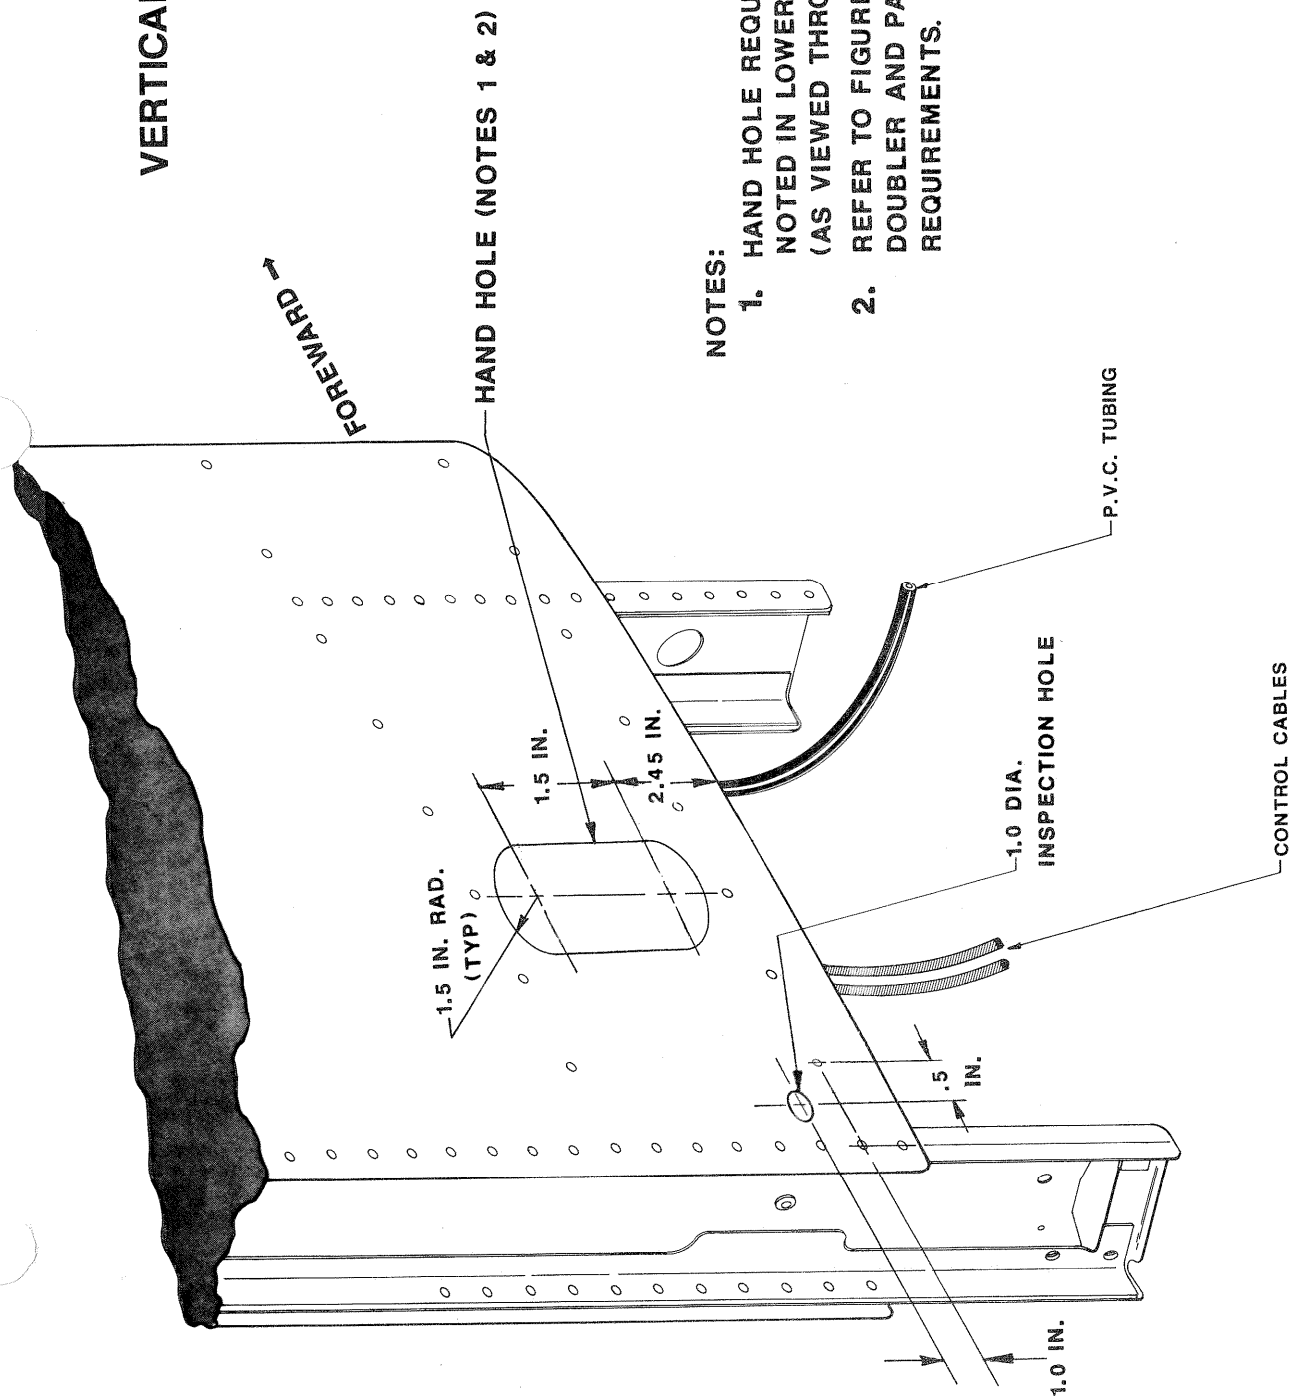
VERTICAL TAIL SECTION

- l. Using a flashlight and inspection mirror, inspect lower tail fin through inspection hole and through rudder pushrod opening.
- m. If debris is noted inside tail fin, proceed as follows:

1. HAND HOLE REQUIRED ONLY IF DEBRIS IS NOTED IN LOWER PORTION OF TAIL FIN (AS VIEWED THROUGH INSPECTION HOLE).
2. REFER TO FIGURE 5 FOR STRUCTURAL DOUBLER AND PATCH INSTALLATION REQUIREMENTS.

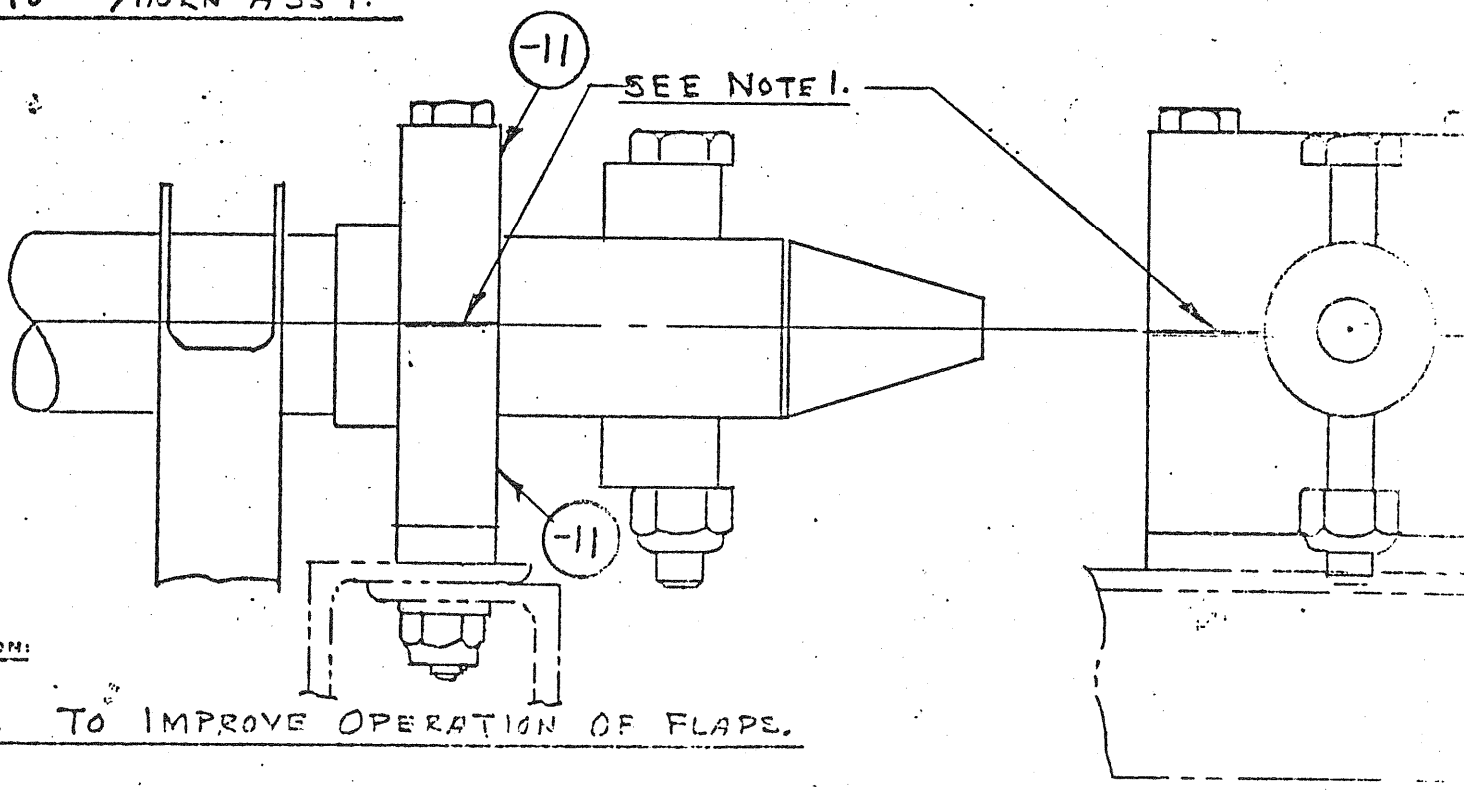
1. - 2. TO IMPROVE OPERATION OF FLAPS.

1. WITHOUT PUSH ROD ATTACHED ADJUST (1) PAIR OF -11 BEARING BLOCKS (L.H.) TO GIVE A FRICTION TORQUE ON TORQUE TUBE OF 5-8 IN. LBS. -11 BLOCK MAY BE FILED LIGHTLY TO ACHIEVE THE FINAL RESULT. WING PANELS SHALL BE REMOVED WHEN DOING THIS MOD.

2. F/D. ADD: SEE NOTE 1. TO CENTERLINE OF (2) -11 BLOCKS ADJACENT TO -7 HORN ASS'Y.
