PUBLICATION INDEX FOR SGS 1-36

K & L SOARING, LLC 5996 STATE ROUTE 224 CAYUTA, NY 14824

BULLETIN NO. SA-001.6* DATE: Dec 29, 2009

SUBJECT: ONE-TIME INSPECTION OF TOW RELEASE ASSEMBLY; DAILY INSPECTION OF TOW RELEASE ASSEMBLY: PILOT'S PREFLIGHT INSPECTION OF TOW RELEASE ASSEMBLY; 100 HOUR/ANNUAL INSPECTION OF TOW RELEASE ASSEMBLY.

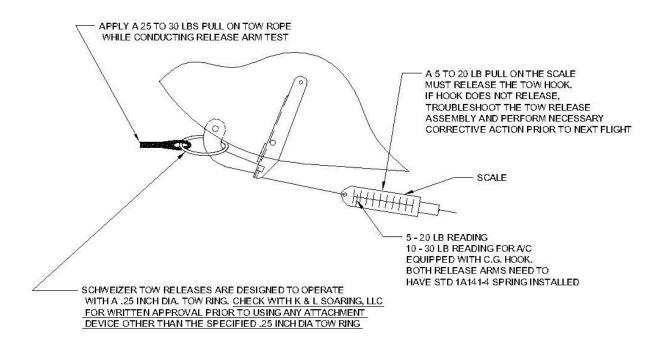
FIGURE 4 - PULL TEST OF TOW RELEASE ASSEMBLY

Perform a release check for proper release tension in accordance with Figure 4.			Х
Lubricate attach hardware for tow hook and release arm.		X	Х
Lubricate guide-tubes in release control with dry stick type lubricant.		X	Х
Insure that tow hook moves freely on pivot bolt.	Х	Х	Х

NOTE: IF RELEASE LOADS ARE TOO HIGH WITH C.G. SYSTEM IT IS PERMISSIBLE TO ADD A LINK TO SHORTEN STD 1A141-2 SPRING. LINK SHOULD BE MADE AS SHOWN BELOW. IF REQUIRED THEY SHOULD BE ADDED TO BOTH RELEASE ARMS TO BALANCE BOTH RELEASE SPRINGS

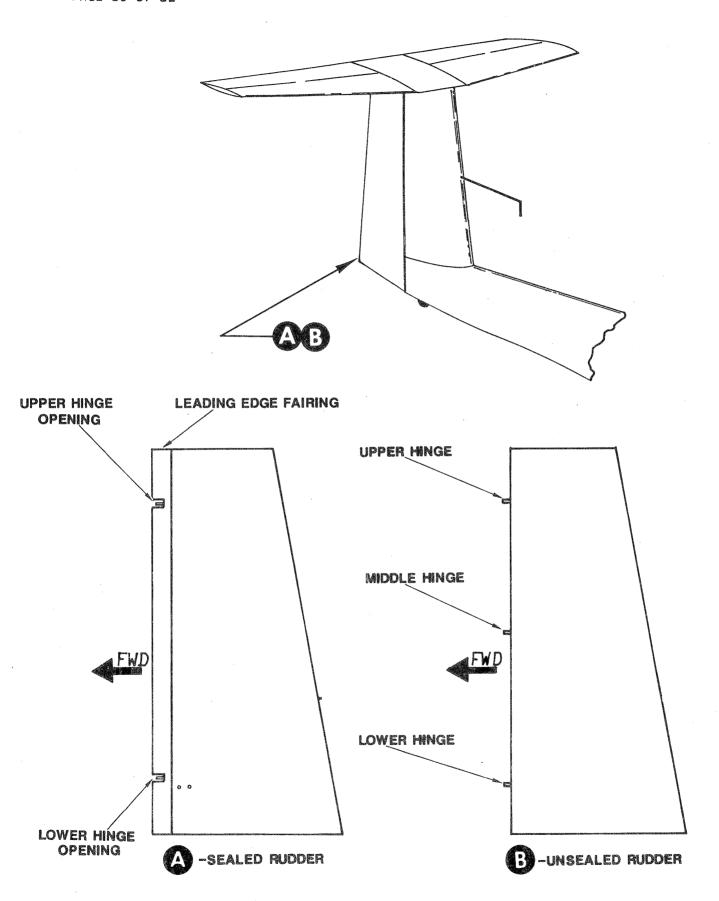
FIGURE 3

One of two types of tail rudders may be installed on the affected aircraft. The earlier type is an unsealed unit without a leading edge fairing (Figure 3, Detail B). The later type is sealed at the leading edge by a fairing (Detail A). Removal of an unsealed rudder is accomplished by performing step a(1) through a(3). A sealed rudder is removed by performing steps b(1) through b(3).

Rodents may gain access and deposit debris at four different locations within the tail rudder. Debris may be present between the leading edge fairing and the spar, inside the lower fairing, inside of the lower bay or inside the upper bay. (Refer to Figure 1.) Each of these areas should be thoroughly inspected with flashlight and inspection mirror.

- a. If an unsealed rudder (Figure 3, Detail B) is installed, remove rudder as follows:
 - (1) Peel off gap tape between rudder and tail fin.
 - (2) Disconnect pushrods at lower end of rudder by removing a cotter pin, nut, washer and bolt from each push rod.
 - (3) Remove cotter pin, nut, and washer from upper, middle and lower hinge bolts at forward end of rudder. Remove hinge bolts.
 - (4) Remove rudder by sliding aft.
- b. If a sealed rudder (Figure 3, Detail A) is installed, remove rudder as follows:
 - (1) Remove cotter pin, nut, and washer from upper hinge bolt. (Do not remove bolt.)
 - (2) Remove four screws securing lower end of rudder.
 - (3) Remove rudder by pulling lower end aft and then sliding rudder upwards off hinge bolt.

- c. Using a flashlight and inspection mirror, inspect for debris inside of rudder by looking through hinge openings (Figure 3, Detail A or Detail B, as applicable).
- d. If debris is noted between leading edge fairing and spar, remove debris through upper hinge opening, using vacuum cleaner and flexible extension hose.
