PUBLICATION INDEX FOR SGS 1-35

K & L SOARING, LLC
5996 STATE ROUTE 224
CAYUTA, NY 14824

BULLETIN NO. SA-001.6*

SUBJECT: ONE-TIME INSPECTION OF TOW RELEASE ASSEMBLY; DAILY INSPECTION OF TOW RELEASE ASSEMBLY; PILOT'S PREFLIGHT INSPECTION OF TOW RELEASE ASSEMBLY; 100 HOUR/ANNUAL INSPECTION OF TOW RELEASE ASSEMBLY.

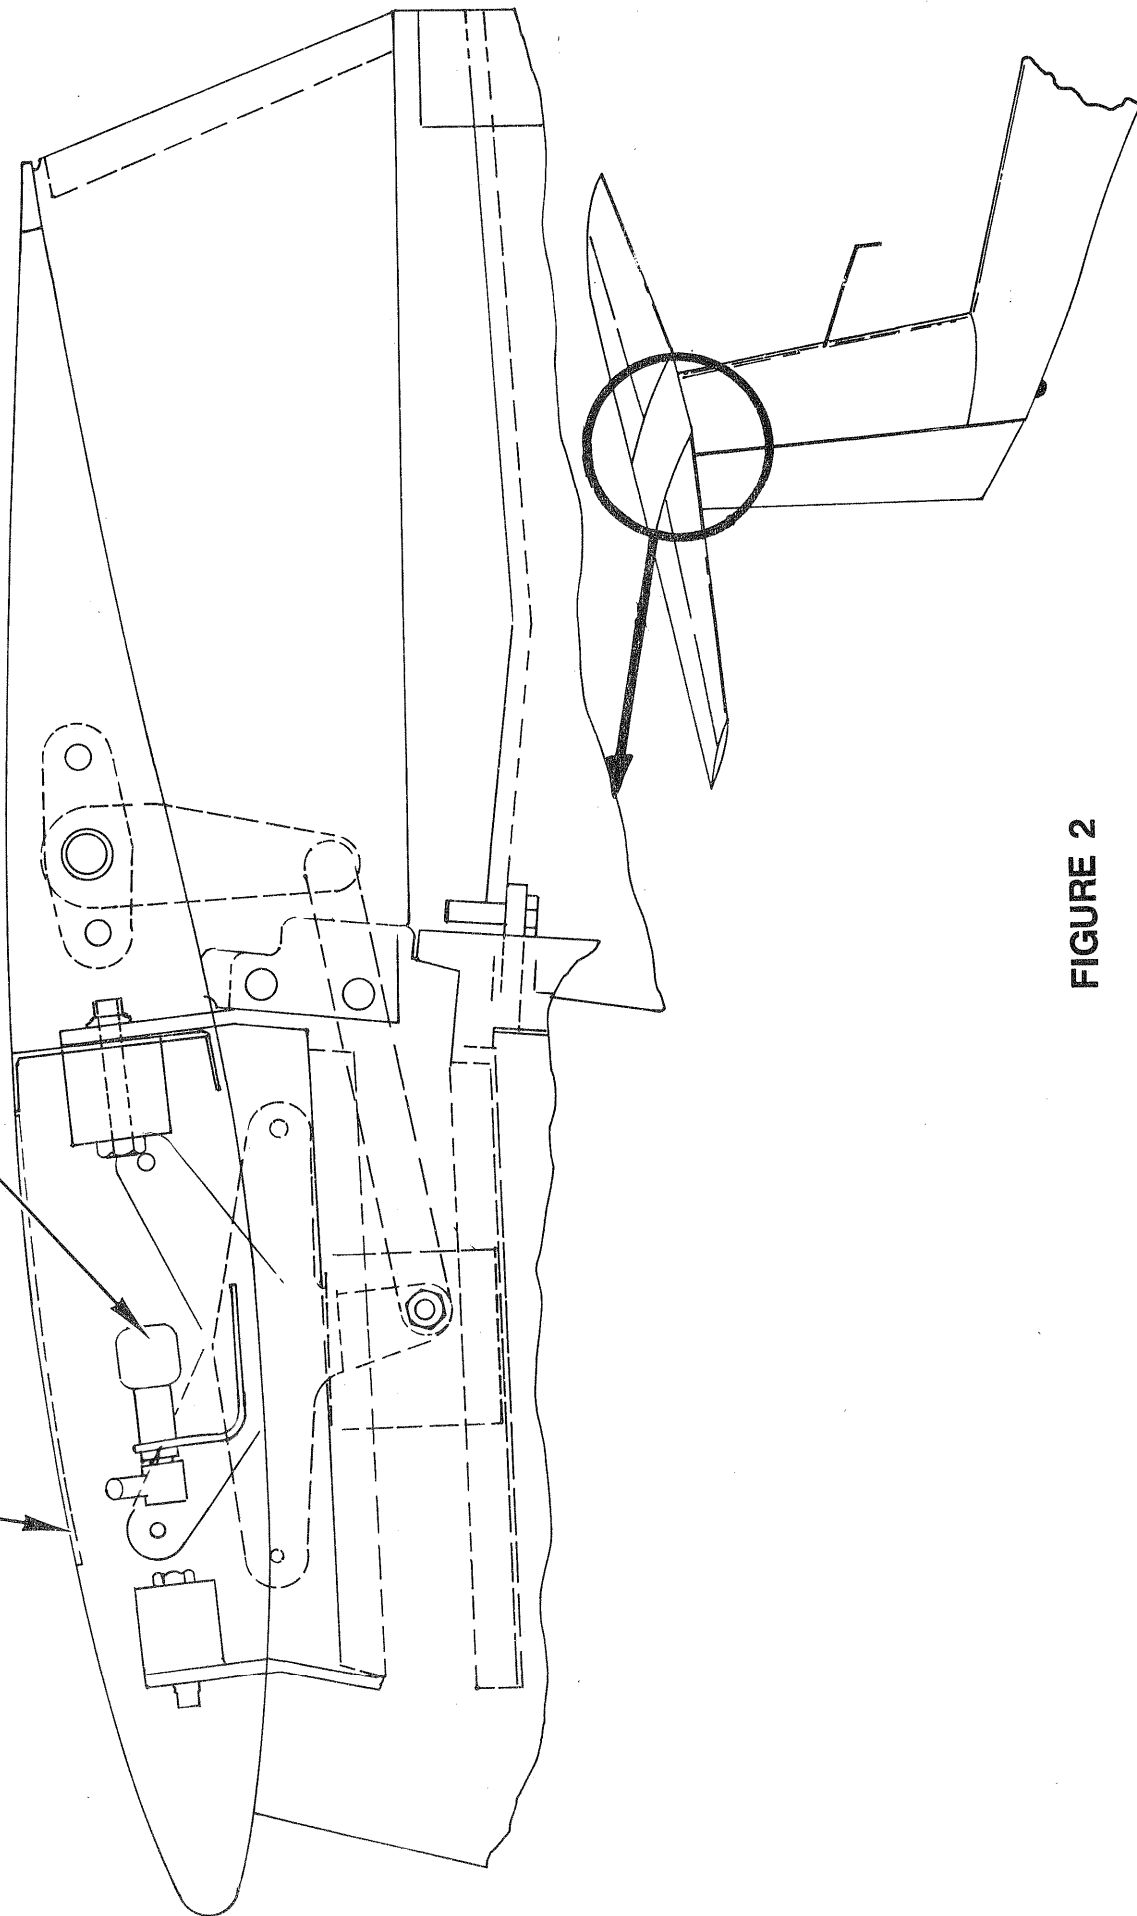
FIGURE 2

ACCESS DOOR
PIP PIN LOCATION

- h. Remove elevators from tail fin as follows:
 - (1) Open access door (Figure 2) on horizontal stabilizer stub.
 - (2) Remove pin securing elevators. (Refer to Figure 2.)

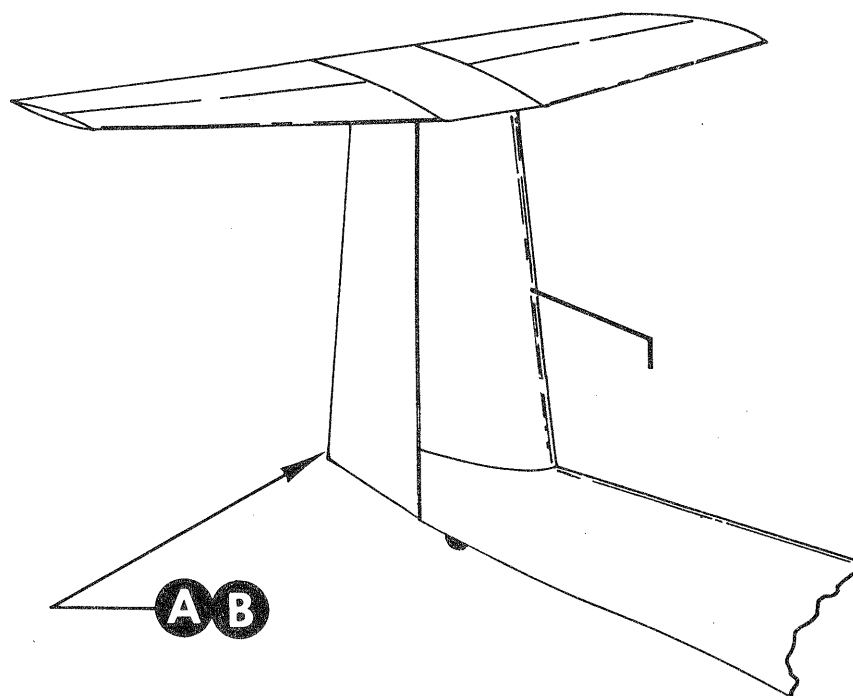
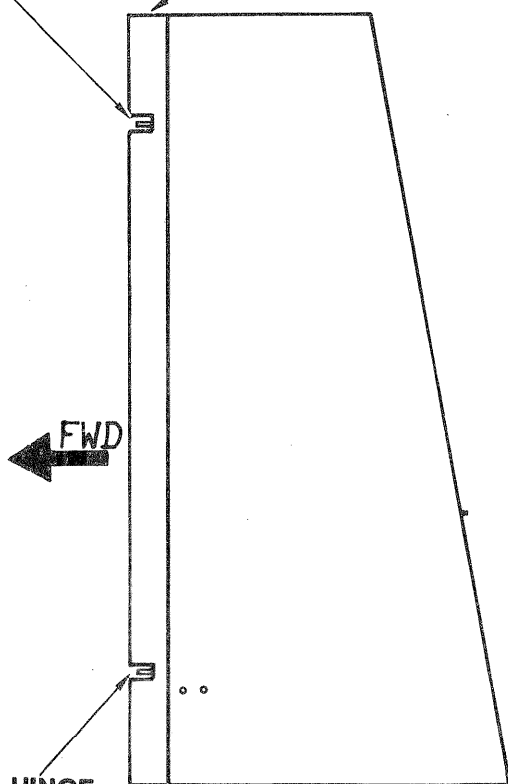
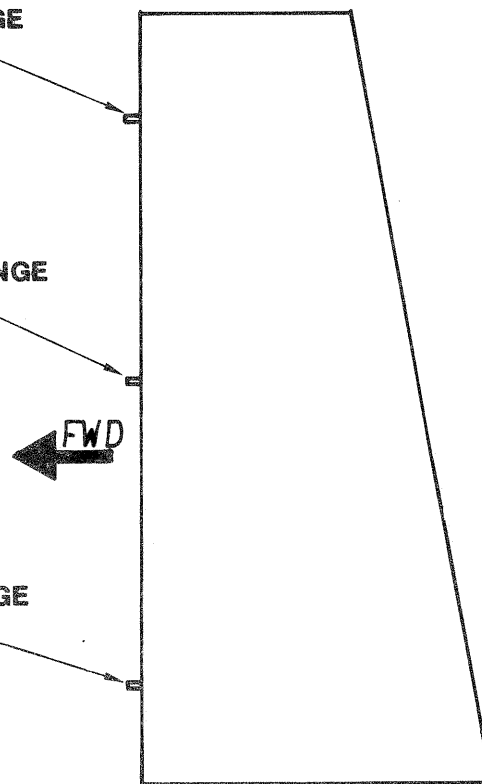
UPPER HINGE
OPENING

LEADING EDGE FAIRING

UPPER HINGE

MIDDLE HINGE

LOWER HINGE

LOWER HINGE
OPENING

A -SEALED RUDDER

- (1) Carefully adjust rudder position to extreme left or right.
 - (2) Using a flashlight, inspect for debris inside lower fairing (Figure 1) by looking through lower hinge opening.
 - (3) If debris is found, use a vacuum cleaner with flexible extension hose to remove debris.
 - (4) Check two drain holes (Figure 1) at bottom of fairing for obstruction. Clear obstructions with 3/16-inch drill bit.
- d. Open access door on horizontal stabilizer stub (Figure 2) and use a flashlight to inspect upper fin and stabilizer stub area for debris. Use vacuum cleaner to remove debris.
- e. Inspect brake/wheel area for obstructions. Remove obstructions as required.
