PUBLICATION INDEX FOR SGS 1-36

K & L SOARING, LLC 5996 STATE ROUTE 224 CAYUTA, NY 14824

BULLETIN NO. SA-001.6* DATE: Dec 29, 2009

SUBJECT: ONE-TIME INSPECTION OF TOW RELEASE ASSEMBLY; DAILY INSPECTION OF TOW RELEASE ASSEMBLY: PILOT'S PREFLIGHT INSPECTION OF TOW RELEASE ASSEMBLY; 100 HOUR/ANNUAL INSPECTION OF TOW RELEASE ASSEMBLY.

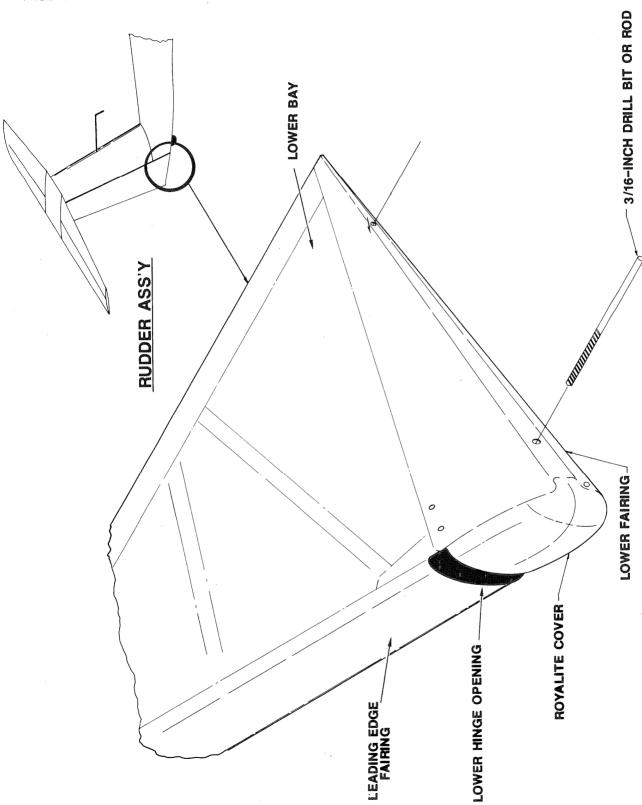
PAGE 8 of 12

- 1. Using a flashlight and inspection mirror, inspect lower tail fin through inspection hole and through rudder pushrod opening.
- m. If debris is noted inside tail fin, proceed as follows:

- q. Check installation for defects and flight controls for proper operation.
- r. Record compliance with Part II of this Service Bulletin in Aircraft Log Book.
